RE: 11380 Smith Road, Aurora, Colorado

APPLICATION FOR INCLUSION IN THE VOLUNTARY CLEAN-UP PROGRAM

11380 Smith Road, Aurora, Colorado

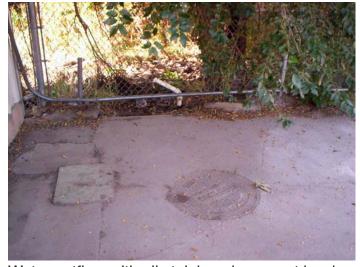
Water outflow with oil staining along west border fence.

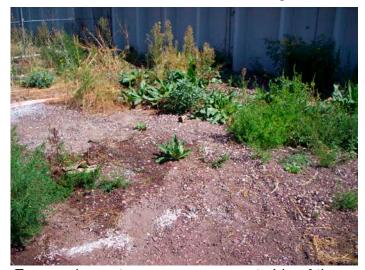
Former drum storage area on west side of the main building.

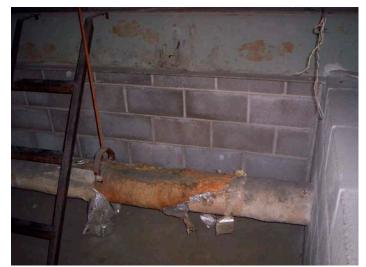
Example of exposed pipe insulation.

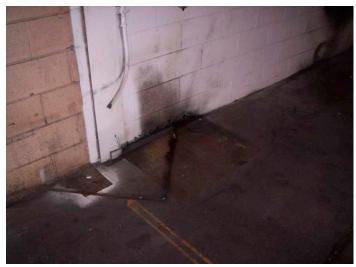
Metal particles and oil staining in fabrication area.

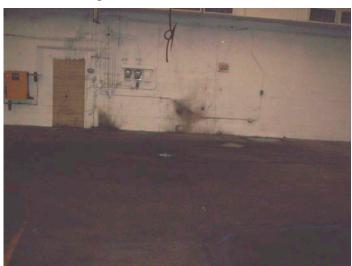
Oil puddles in fabrication area.

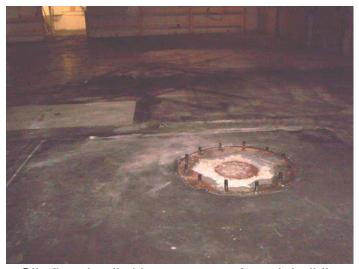
Oily floor in oil skimmer room of south building.

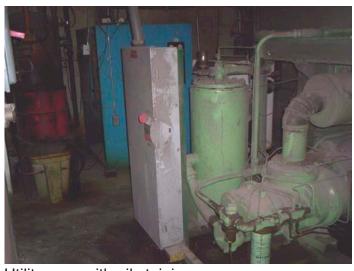
Utility area with oil staining.

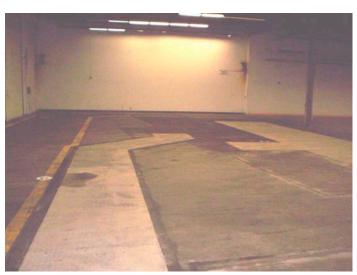
Oil line trenches in press area of main building, backfilled & covered with concrete.

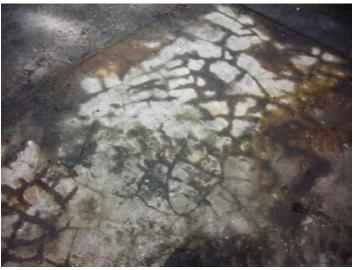
Example of cracked floor with oil staining in oil skimmer room of south building.
